Manhole Inspection Summary

Manhole # S29EE2008MH

Insp Date: **12/5/06 10:06 AM**

Location Address: **5706 GREENLEAF RD** Cross Street: **MELROSE AVE**

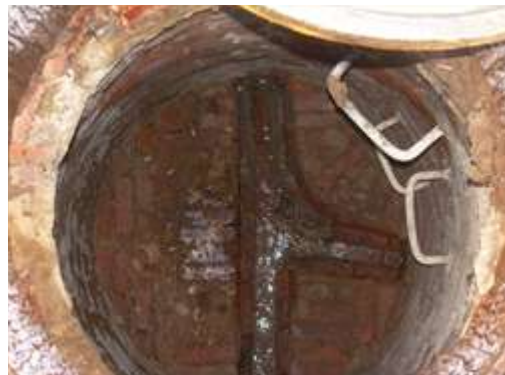
Top View

Frame leak

Cracked cover

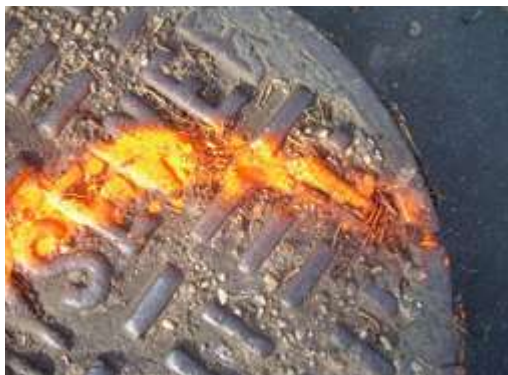
Defect

Adjustment, Corbel and Barrel infiltration - other side.

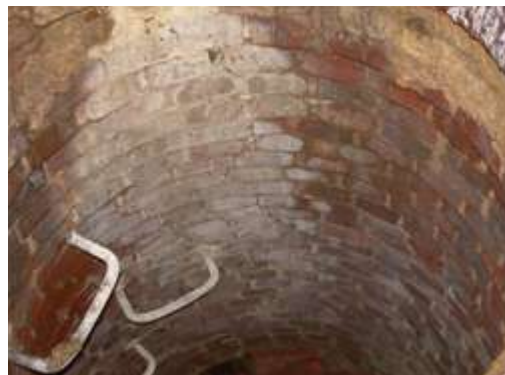
Defect

Frame leaks. Frame offset. Adjustment deterioration, loose brick and infiltration. Corbel infiltration.

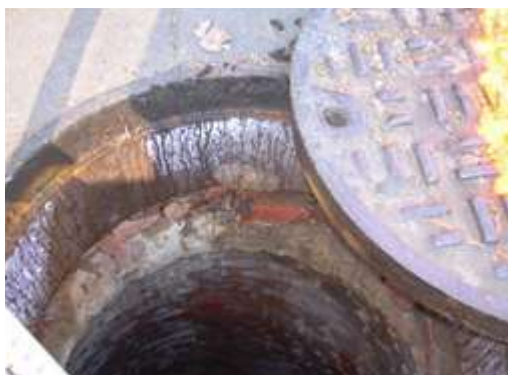
Defect

Adjustment, Corbel, and Barrel infiltration.

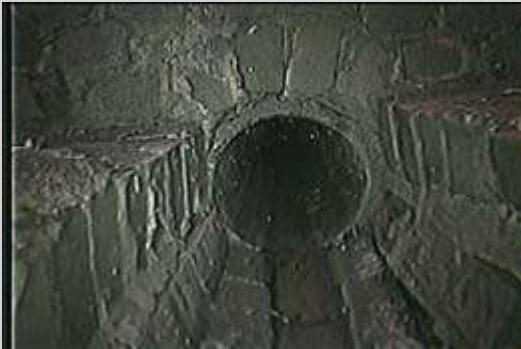
8 in. Circular Gravity Sewer Pipe Out @ 12 O'Clock

Invert Depth: **8.22** (ft.) Flow Characteristics: **Slow**

Infiltration: **Evidence** Pipe Seal Cond: **Cracked**

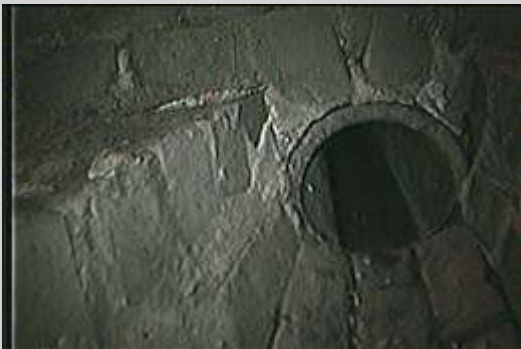
6 in. Circular Gravity Sewer Pipe In @ 3 O'Clock

Infiltration: **Evidence** Pipe Seal Cond: **Unknown**

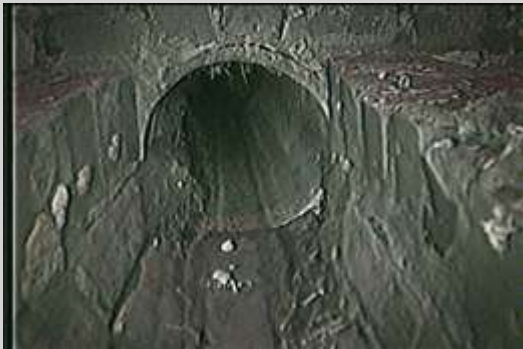
8 in. Circular Gravity Sewer
Pipe In @ 6 O'Clock

Infiltration: **Evidence** Pipe Seal Cond: **Roots**
